**Banneker School Restoration and
Master Plan
for the
Banneker School Foundation and
Historic Site
Parkville, Missouri**

**FINAL DRAFT
April 24, 2010**

BANNEKER SCHOOL MASTER PLAN

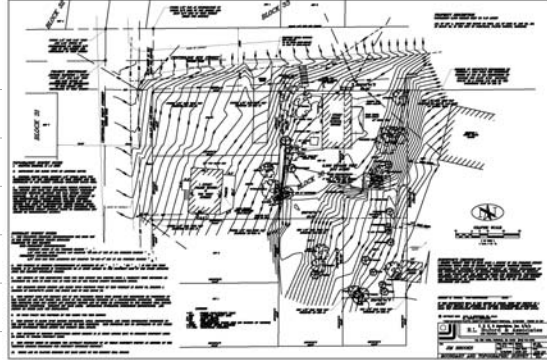
Topographical Survey of Existing Properties

The property that the school sits on is extremely steep with two semi-level areas on the south and east. Some of the grade slopes toward the school. The stone foundation is largely exposed on the north and west. The door to the basement is located on the west and has a small retaining wall adjacent. There is an existing power pole on the north with no apparent power currently running into the building. Also on the north are two existing sets of steps, one concrete which is probably not original, and one comprised of stone slabs that may be original. Neither meet Code, nor do they run to the street. They are not safe for public use due to settlement, no landings, and lack of handrails.

There is an existing underground storage structure to the southeast of the school. It is a stone and concrete structure that appears to be in stable condition. There is no door on the structure, and it is filled with miscellaneous items, including some salvaged brick. It is probable this

To the southwest of the school, near the property line, is a stone retaining wall. It appears the retaining wall is stable but in need of some work. There are several loose stones near the top of the retaining wall.

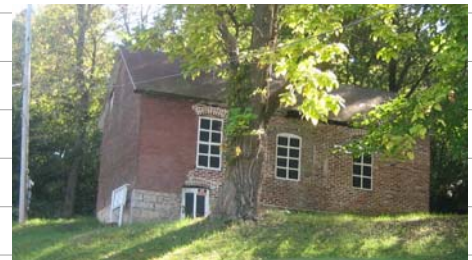
The building is constructed of a double wythe brick wall in a Flemish bond resting on an 18" stone foundation. In the recent past, the addition on the south was removed as well as a chimney on the west side. Two non-original window openings on the west were infilled and the three original openings were re-stored. It is evident on the west elevation where stone and brick were replaced. The stone does not match the original exactly but is a close match. The infill brick was not re-installed following the Flemish bond pattern and the mortar does not match the original in color or texture.

All original openings are intact. On the east elevation, a new door was added at one of the window openings and still remains. All openings are covered with plywood with the exception of the non-original door.

The metal roof was added in the recent past. The eaves and fascia are in a very deteriorated condition, with several large gaps where the fascia is missing completely. As such, the interior is exposed to the weather.

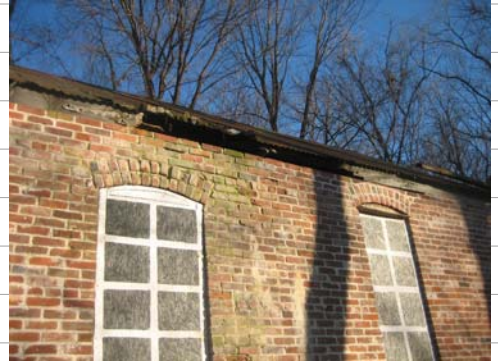
West Elevation

The West elevation has had the three original window openings restored; two non-historic windows closed up, and the non-historic chimney removed. There is significant damage to the fascia and eave; it is completely missing for several feet allowing the elements to enter the school. The brick is in decent shape for the most part. Where the chimney was removed, some of the brick face has spalled off. Starting above the door to the basement and extending to the south of the northern window, it is apparent that some repointing was done as the mortar color does not match the rest of the elevation. It appears that the northern portion of this elevation has some type of paint coating. A crack was noted at the northern window sill.

The stone appears to be in good shape where exposed. There is evidence of soil to the southern end indicating that the grade may be sloping towards the school.

The condition of the door to the basement could not be assessed due to the plywood currently covering the opening. From the previous assessments it is believed that the original door may be in tact in this opening.

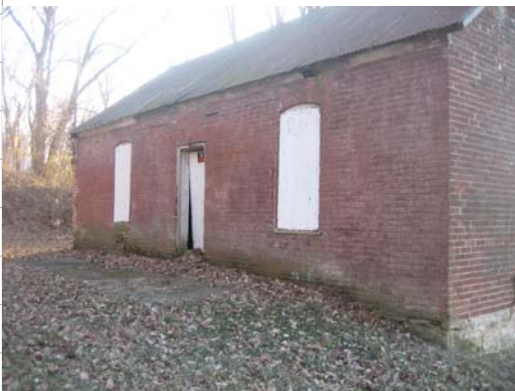
This elevation has significant damage to the brick. The brick under the southern window is spalling and loose in places. The brick at the door that was cut-in when the school was converted to a residence is literally falling out towards the bottom of the jambs. The brick at the base of wall at the southeast corner is also very loose. There is apparent repointing that was performed at the southeast corner in recent past, it appears that inappropriate mortar was used, and a crack has formed in the brick just north of this corner most likely caused by inappropriate mortar hardness.

The stone foundation is not exposed on this elevation. Its condition cannot be assessed from the exterior.

The eave and fascia are also very deteriorated and missing in places.

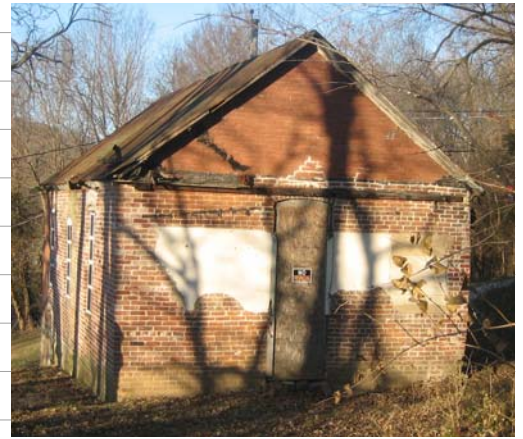
South Elevation

The south elevation still shows evidence of the kitchen addition that was removed. There are tar stains from the addition's roof, and some plaster still remains from what would have been the finish for the kitchen. There is also a wood rim board that exists from where the old roof tied into the existing school. At the base are significant signs of soil which indicates that the drainage and grade in this area requires attention. Upon inspection of the building, it was also noted that immediately outside the original entrance into the school, the ground is extremely soft and depressed. This would indicate when the basement that was under the kitchen addition was removed it was not properly backfilled. There are loose bricks located under the door threshold.

The mortar joints differ in color between the lower and upper sections of the gabled end. This could be from the addition of plaster to the lower section, or there was inappropriate repointing done in the past.

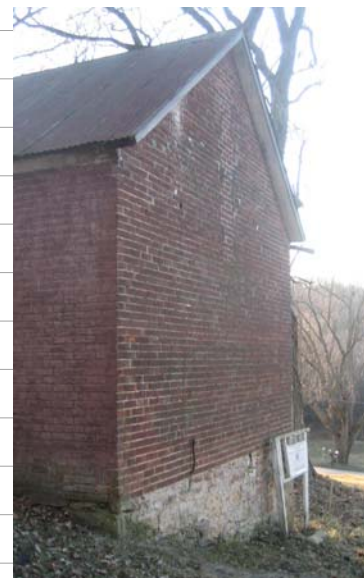
North Elevation

The brick and stone on the north elevation are in stable condition. The hole where the stove pipe would have come through the wall has been in-filled.

There is exposed conduit on the exterior of the building where the power probably entered the school at one point.

The eave appears in decent shape and should be salvageable.

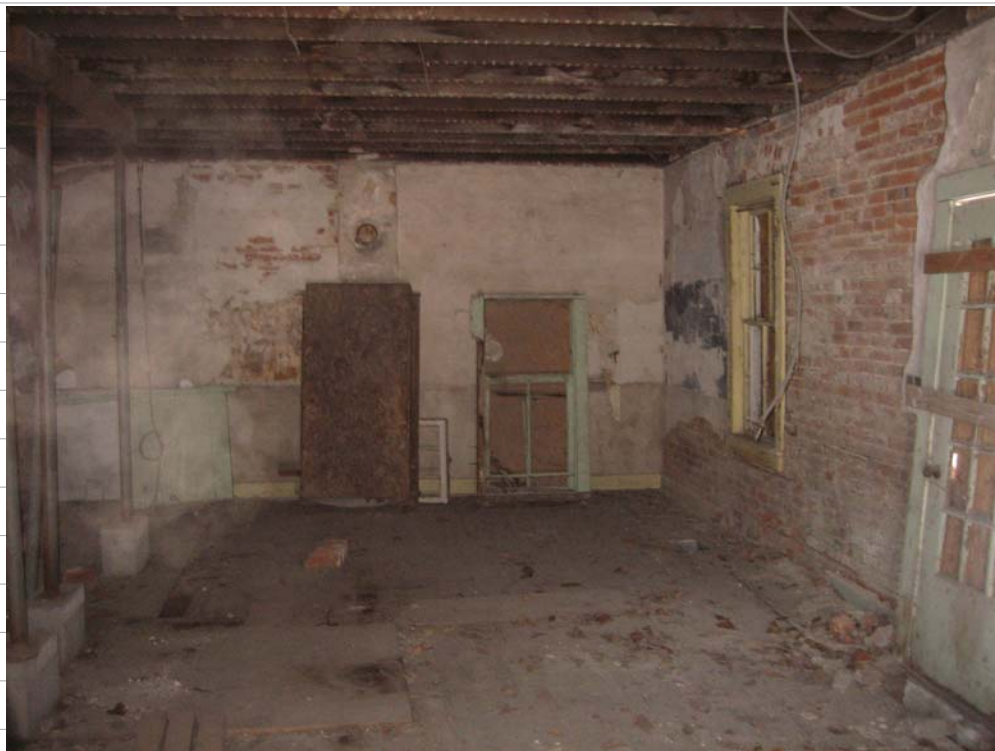
Interior looking North

The interior has suffered from years of neglect and exposure to the elements. The floor has several holes. There is evidence of termite damage as well as wood rot in the floor joists. The west side of the roof is currently supported by shoring as most of the joists on this end have rotted beyond the ability to carry the roof load. In several cases, the joists no longer reach the bearing plate on the wall. All remnants from when the school was converted to a house have been removed, but there is evidence where walls were removed and where the added fireplace was removed.

The ceiling joists appear to be original and suffer from the same deterioration at the ends as the roof joists. Evidence of plaster lath is evident although no ceiling plaster remains.

As noted in the building exterior section, the brick walls have suffered from inappropriate re-pointing and years of neglect. There is no significant bowing or specific structural concerns at this time, but given some evident cracking and spalling on the exterior, the walls need to be addressed in the near future.

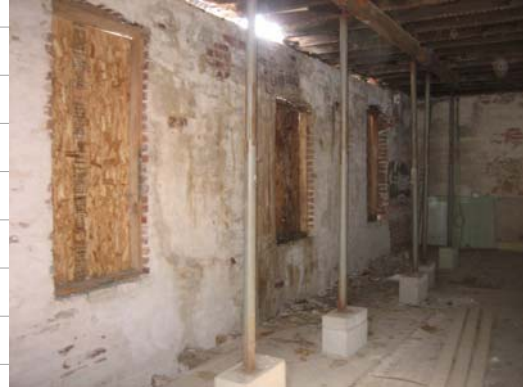
West Interior Elevation

The west interior had a masonry parge coating added at some point in the recent past. Very little plaster remains on this elevation. Because of the parge coating, it is not clear what condition the brick is in. Similar to the east elevation, evidence of the original painted chalkboard still exists on the northern portion of the wall. There are no windows in the window openings, however, two windows are located inside that presumably once occupied two of the three window openings. No window trim remains.

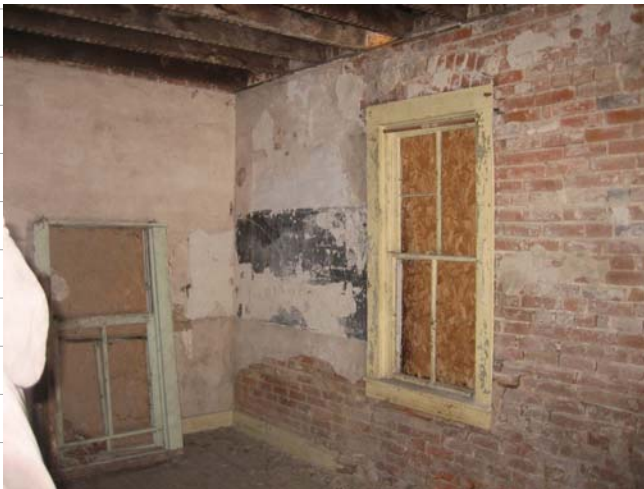
East Interior Elevation

The east interior has very little plaster remaining. The exposed brick is in very poor shape. The original windows are still in the north and south window openings, albeit in very bad shape but salvageable. What appears to be the original window trim is still in place. The existing door on this elevation was added when the school was converted to a residence and is considered non-historic. The arch over the original window opening is still intact and the opening can easily be restored back to a window opening. Evidence of the original painted chalkboard still exists on the northern portion of the wall.

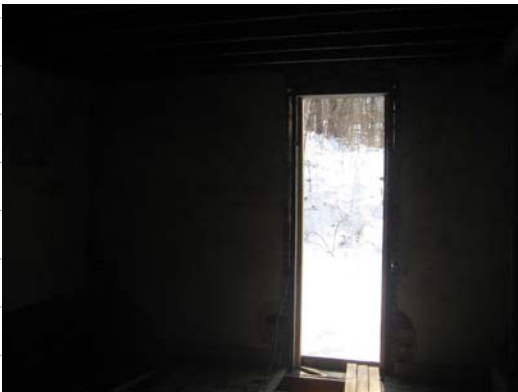
South Interior Elevation

The south interior is where the original door into the school is located. The original door frame and some trim remain intact. The original door is located on site and will require repair but should be able to be reused. The transom that existed above the door no longer exists. Some plaster also remains on this wall, but as stated previously, it is necessary to remove it to repoint the brick wall to protect its structural integrity.

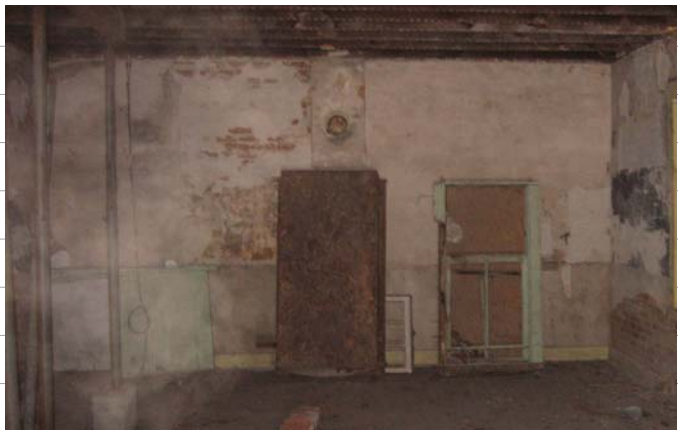
North Interior Elevation

The north interior wall still has a small portion of existing wood wainscot. The hole from the old stove pipe still exists as well. Some plaster remains, but given the fact that the brick needs to be repointed on both the interior and exterior, it should be removed.

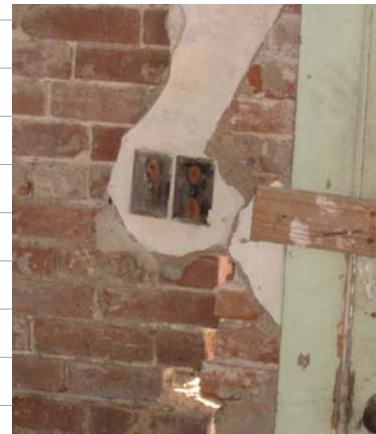
Light Switches on East Elevation

The building does not currently have any power. There are remnants of electrical conduit on the interior and exterior. Because the basement was inaccessible, it is unclear whether an electrical panel exists. It is also unclear whether the existing furnace installed when the school was used as a residence still exists in the basement. There is no evidence of any ductwork or registers on the first floor. It appears that the plumbing was completely removed from the first floor. Again, it is uncertain whether any plumbing remains in the basement. If any sewer lines are still in place around the perimeter, these will be uncovered at such time as the foundation is excavated and can be removed at that time.

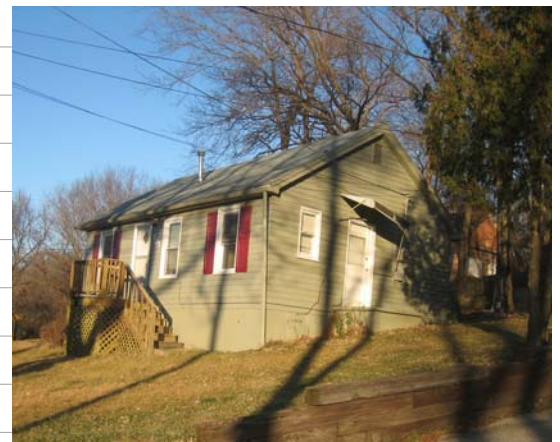
703 West Street looking northeast

Similar to the school property, the west property has very steep grades. Currently, the residence is a rental property. It is a simple wood-frame rectangular structure, approximately 565 gross square feet. The foundation is constructed of concrete masonry units. It has a crawl space. The building is clad in wood siding and has a composite shingle roof.

On the west, the main entrance is accessed by a wooden stair. On the south is another exterior door. On the east is a low level wooden deck with a sliding door to the interior. There is a gravel drive coming off of 8th Street. BeFree Architecture was not able to obtain access to the interior.
